historic structure report
architectural data section
phase II: exterior preservation

JEFFERSON NATIONAL EXPANSION MEMORIAL
OLD COURTHOUSE

HISTORIC STRUCTURE REPORT
Architectural Data Section
Phase II: Exterior Preservation

by
David G. Henderson

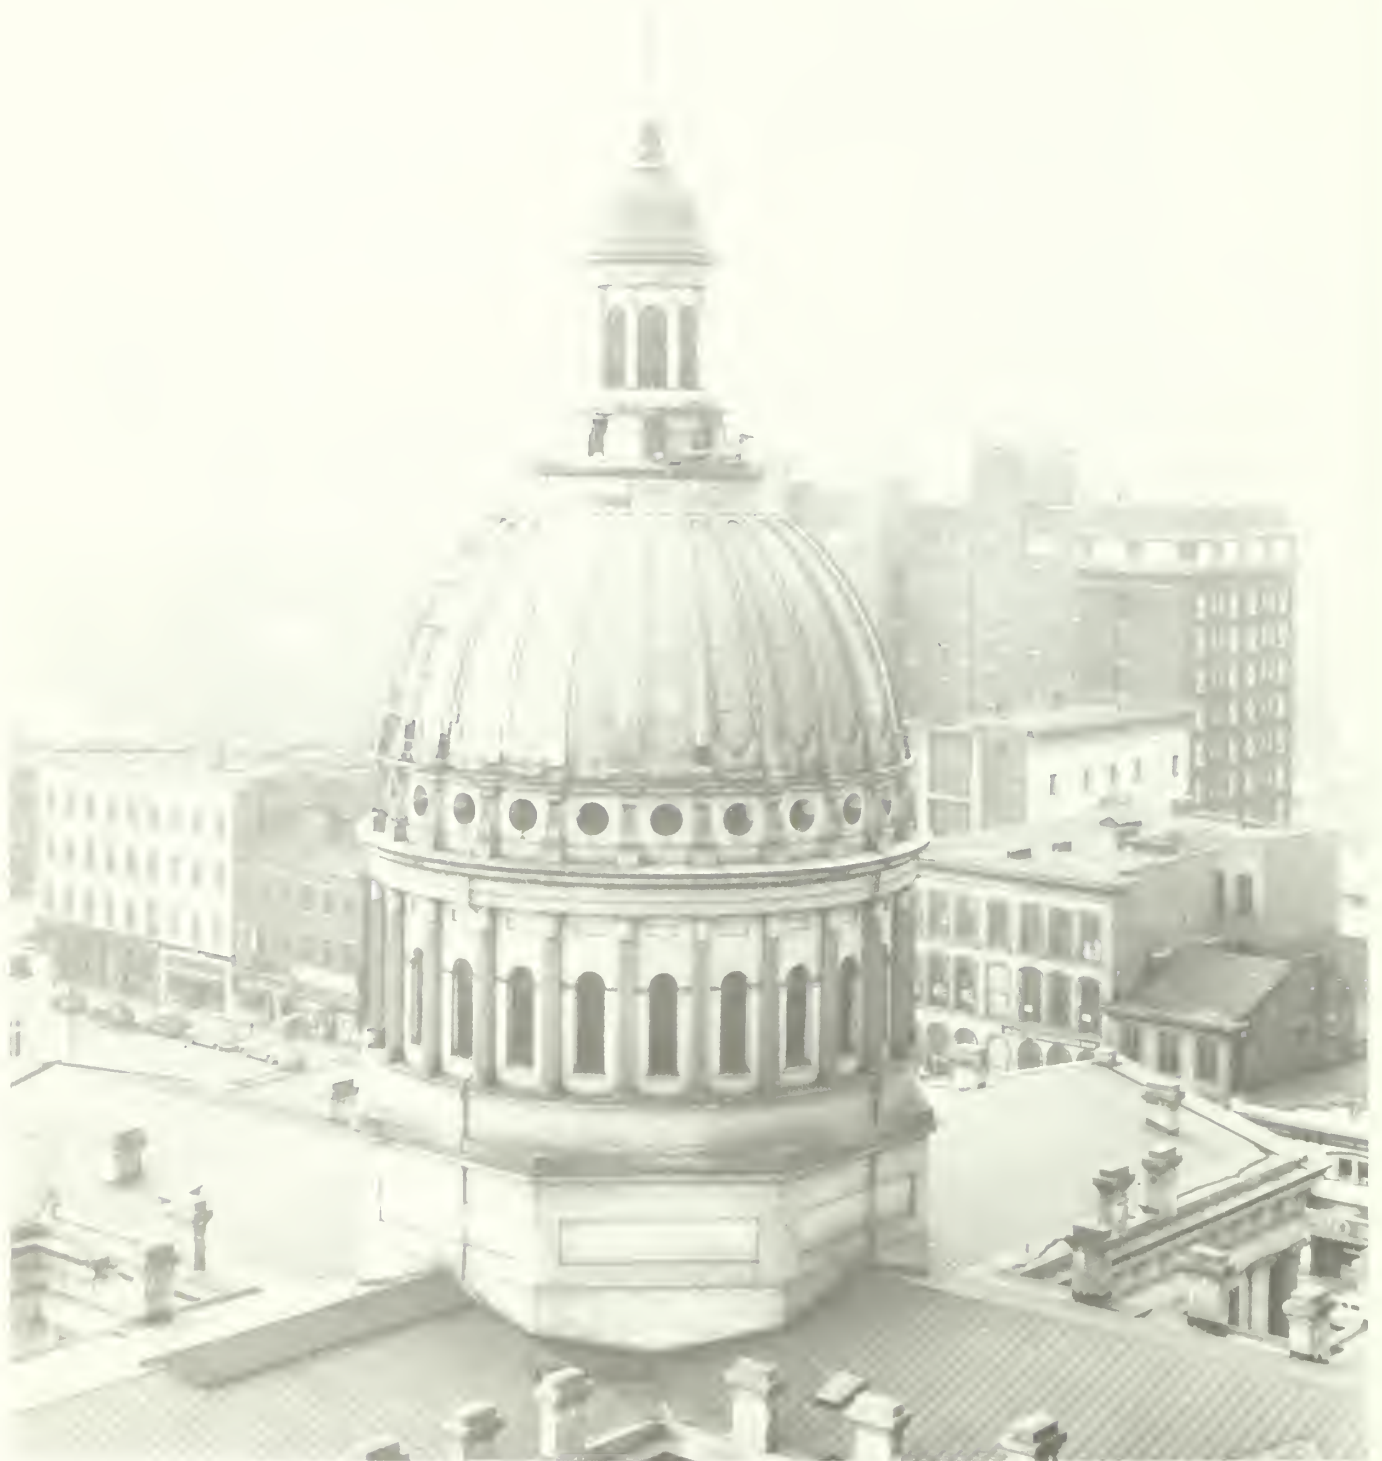
5. Applying new copper over dome. Photo looking southwest, January 17, 1948.

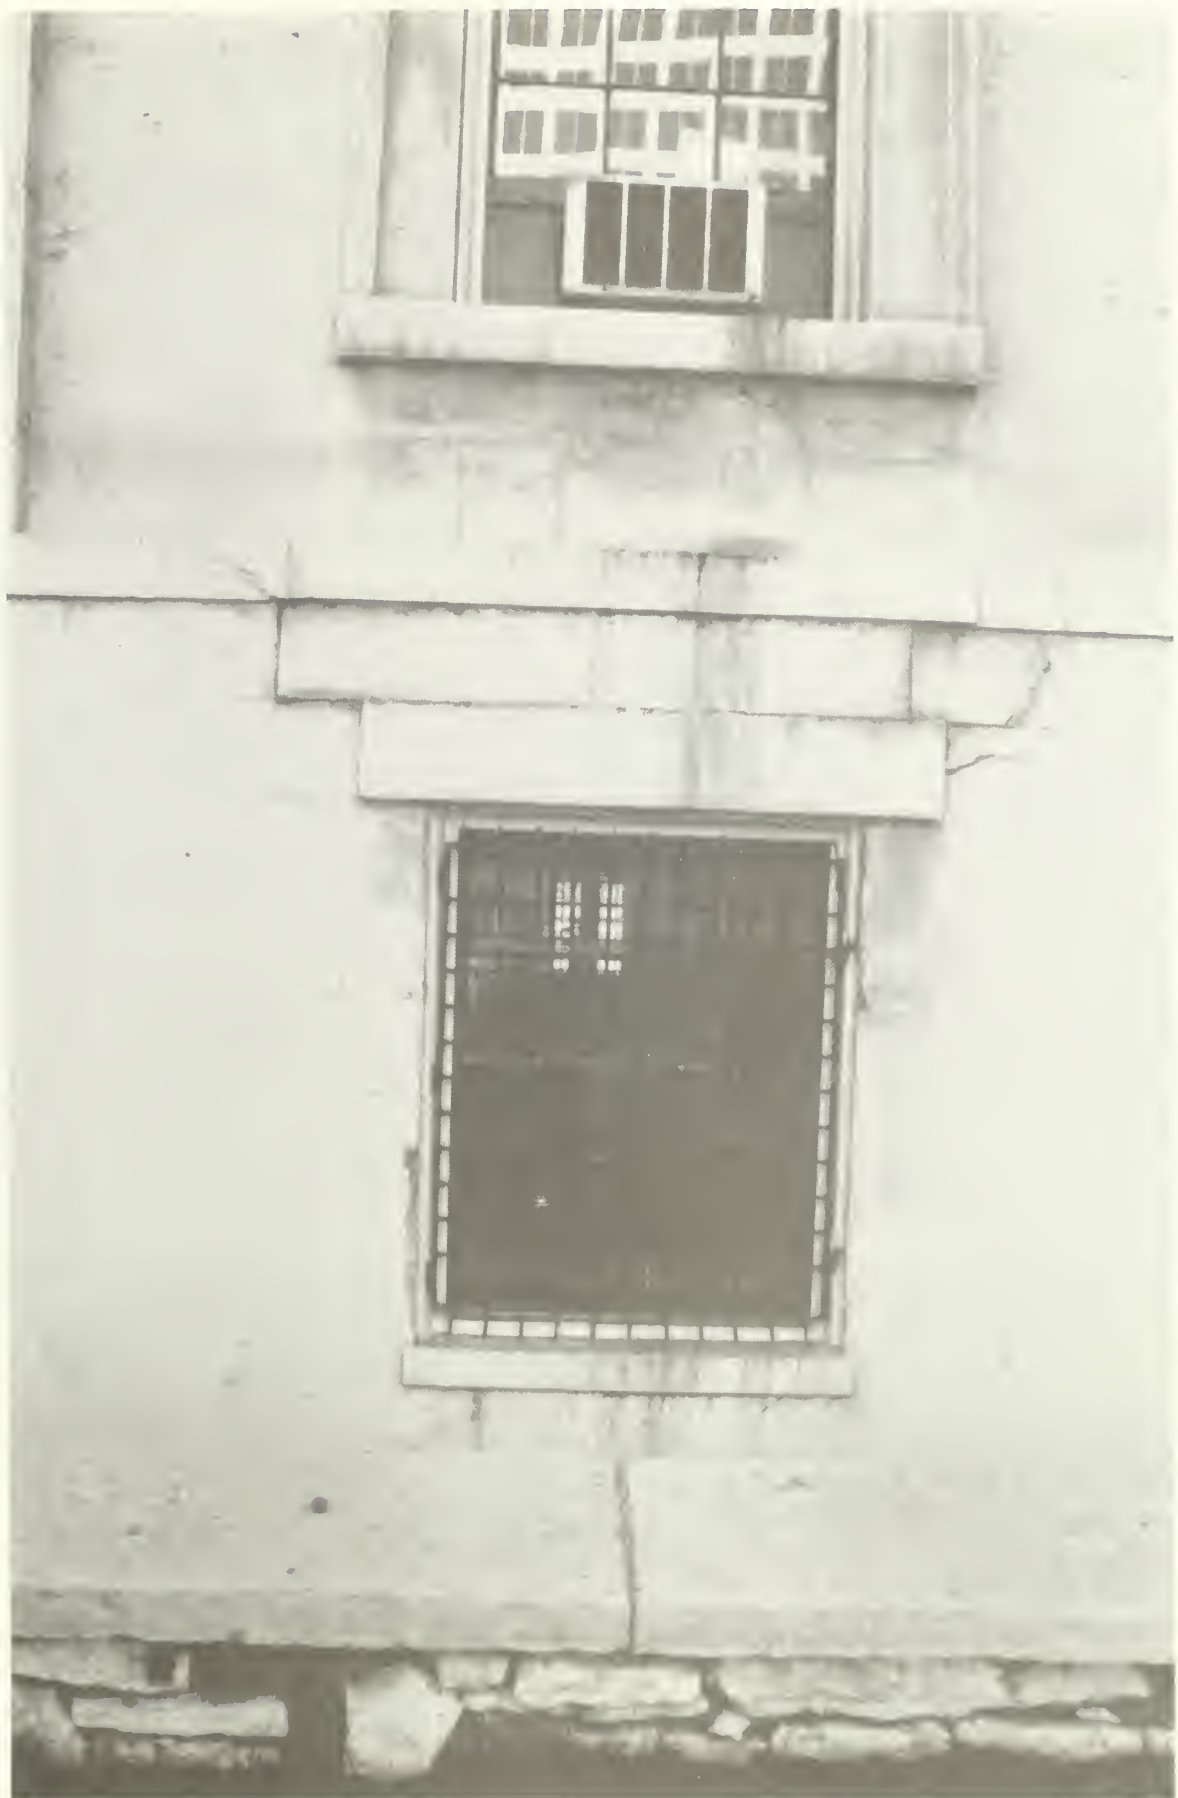
32. Displaced stones at basement window, north side of east wing (south side similar).

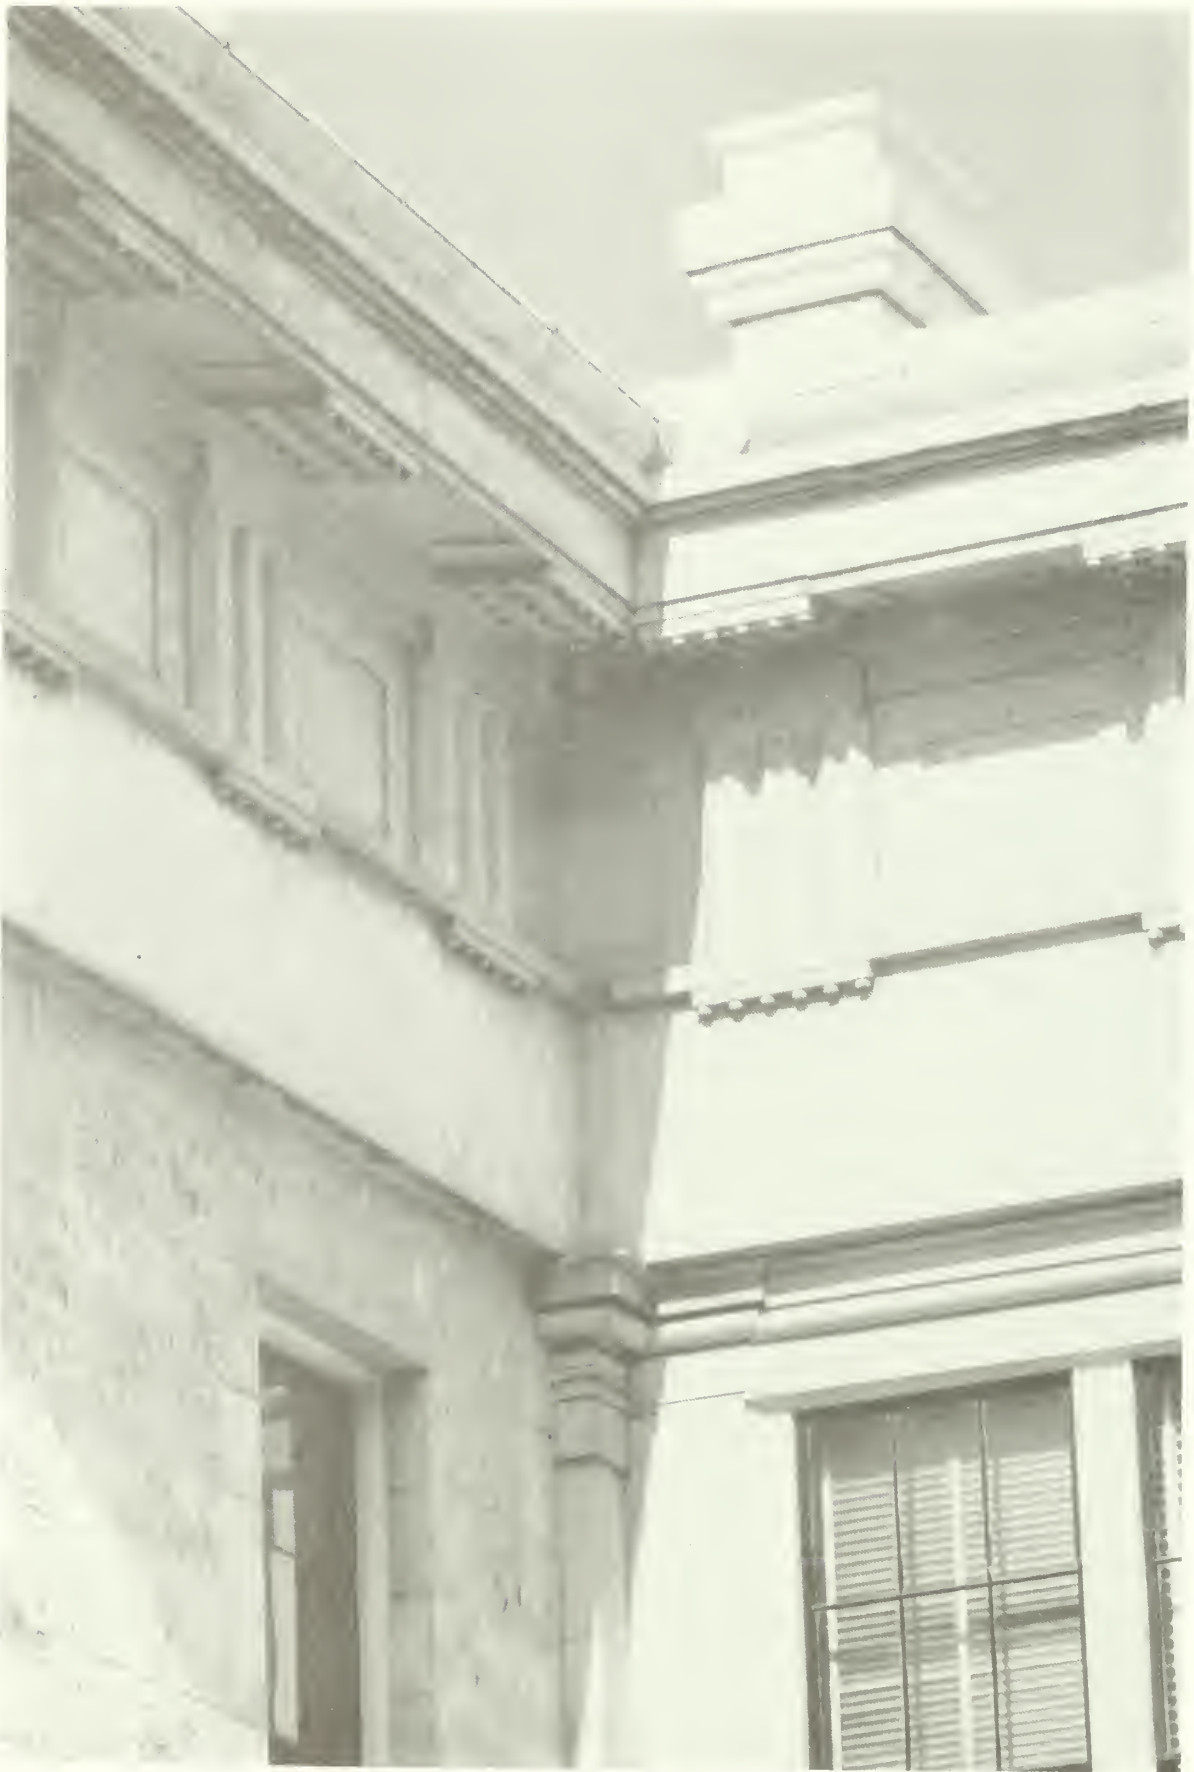
35. Typical inside corner of cornice.

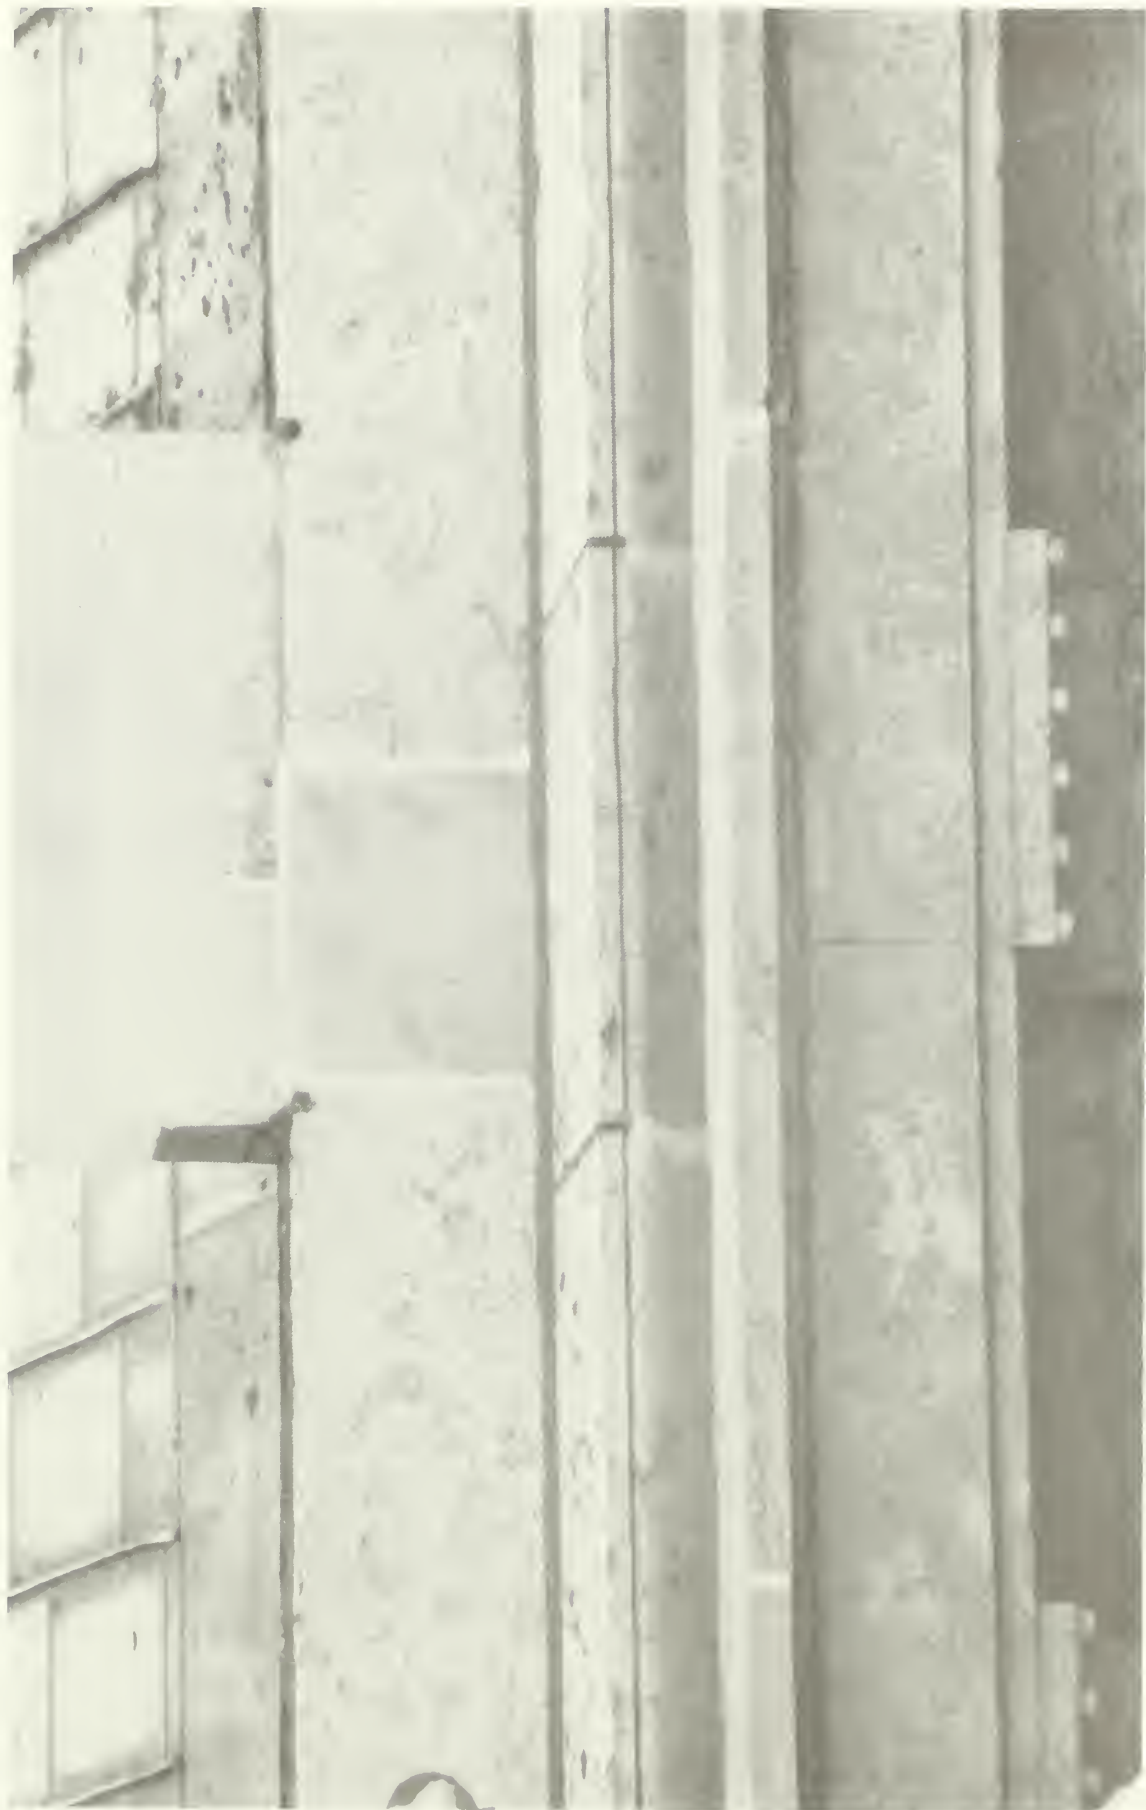
36. Cornice section in relatively good condition. Note replacement stone in parapet.

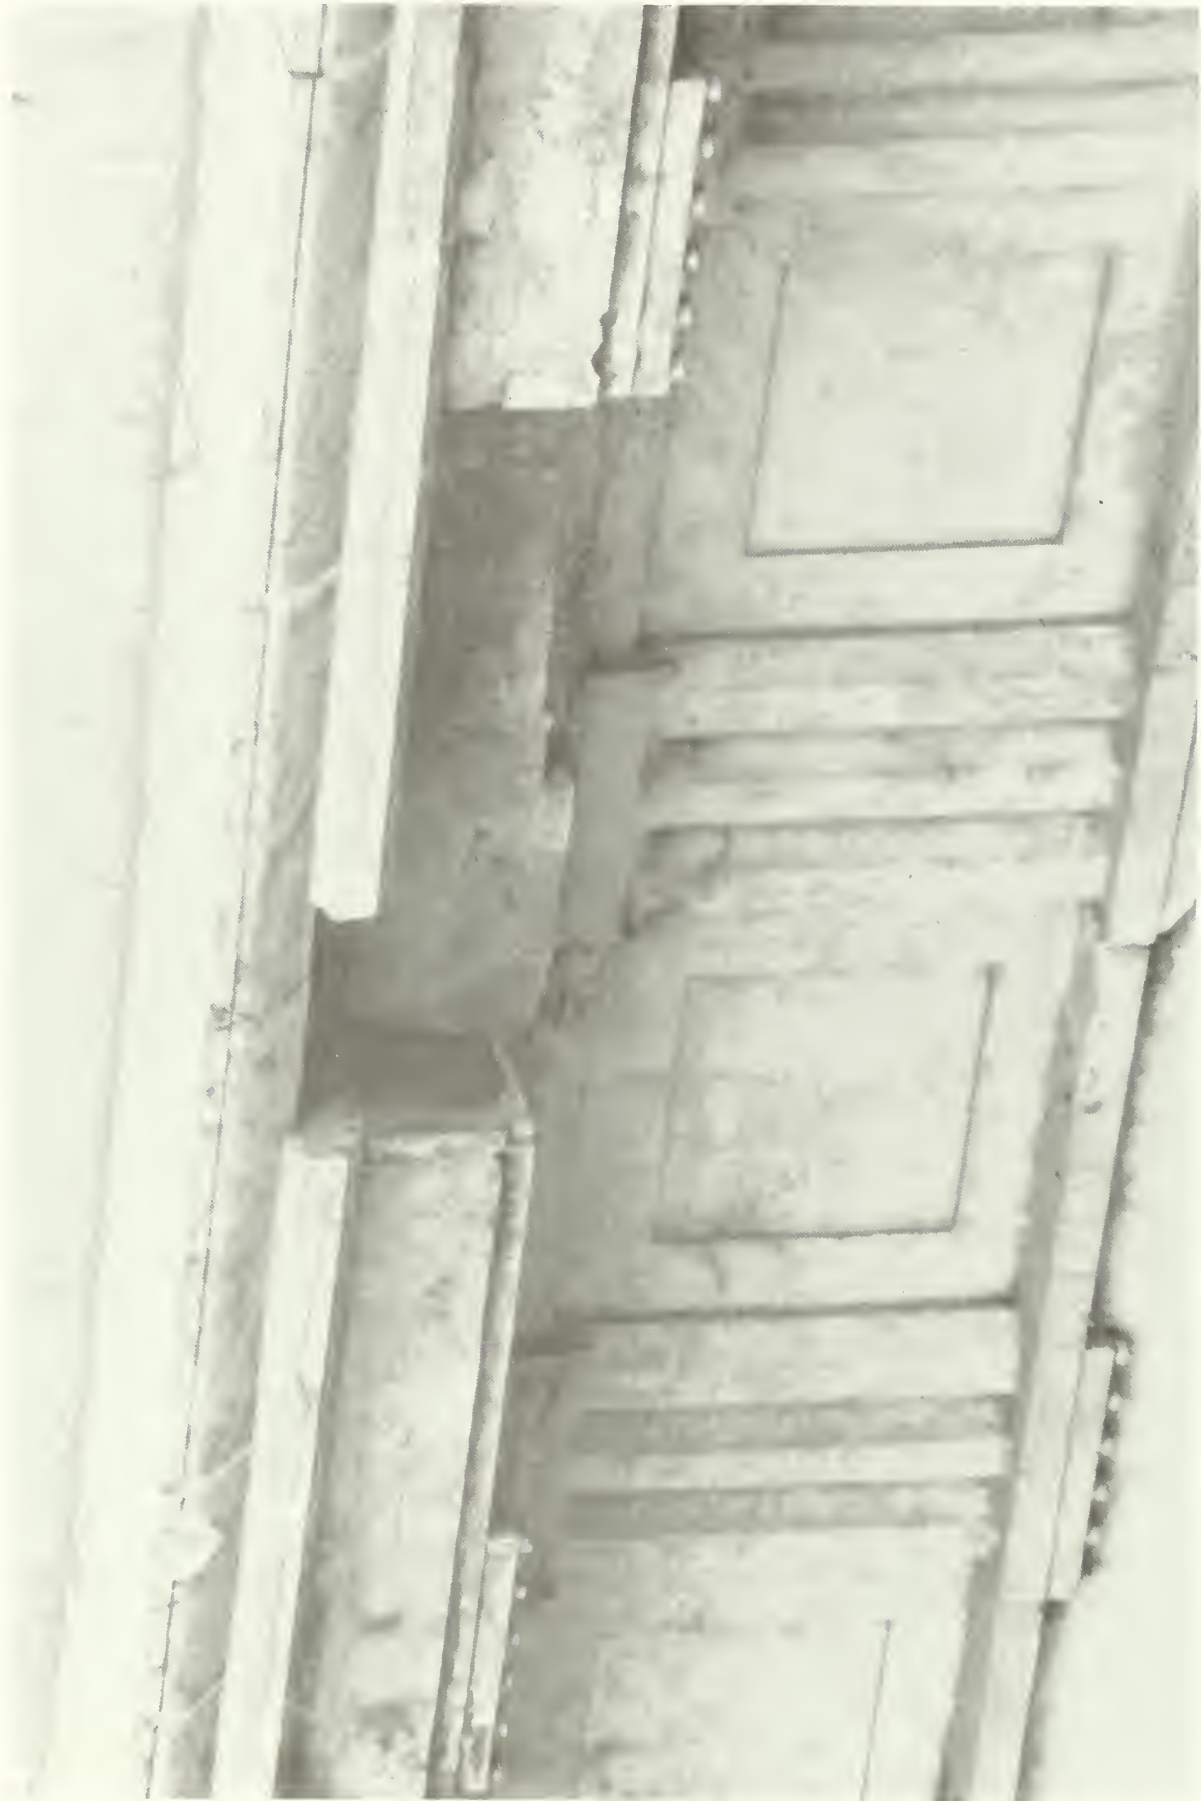
41. Missing section of cornice, north side of east wing near portico.

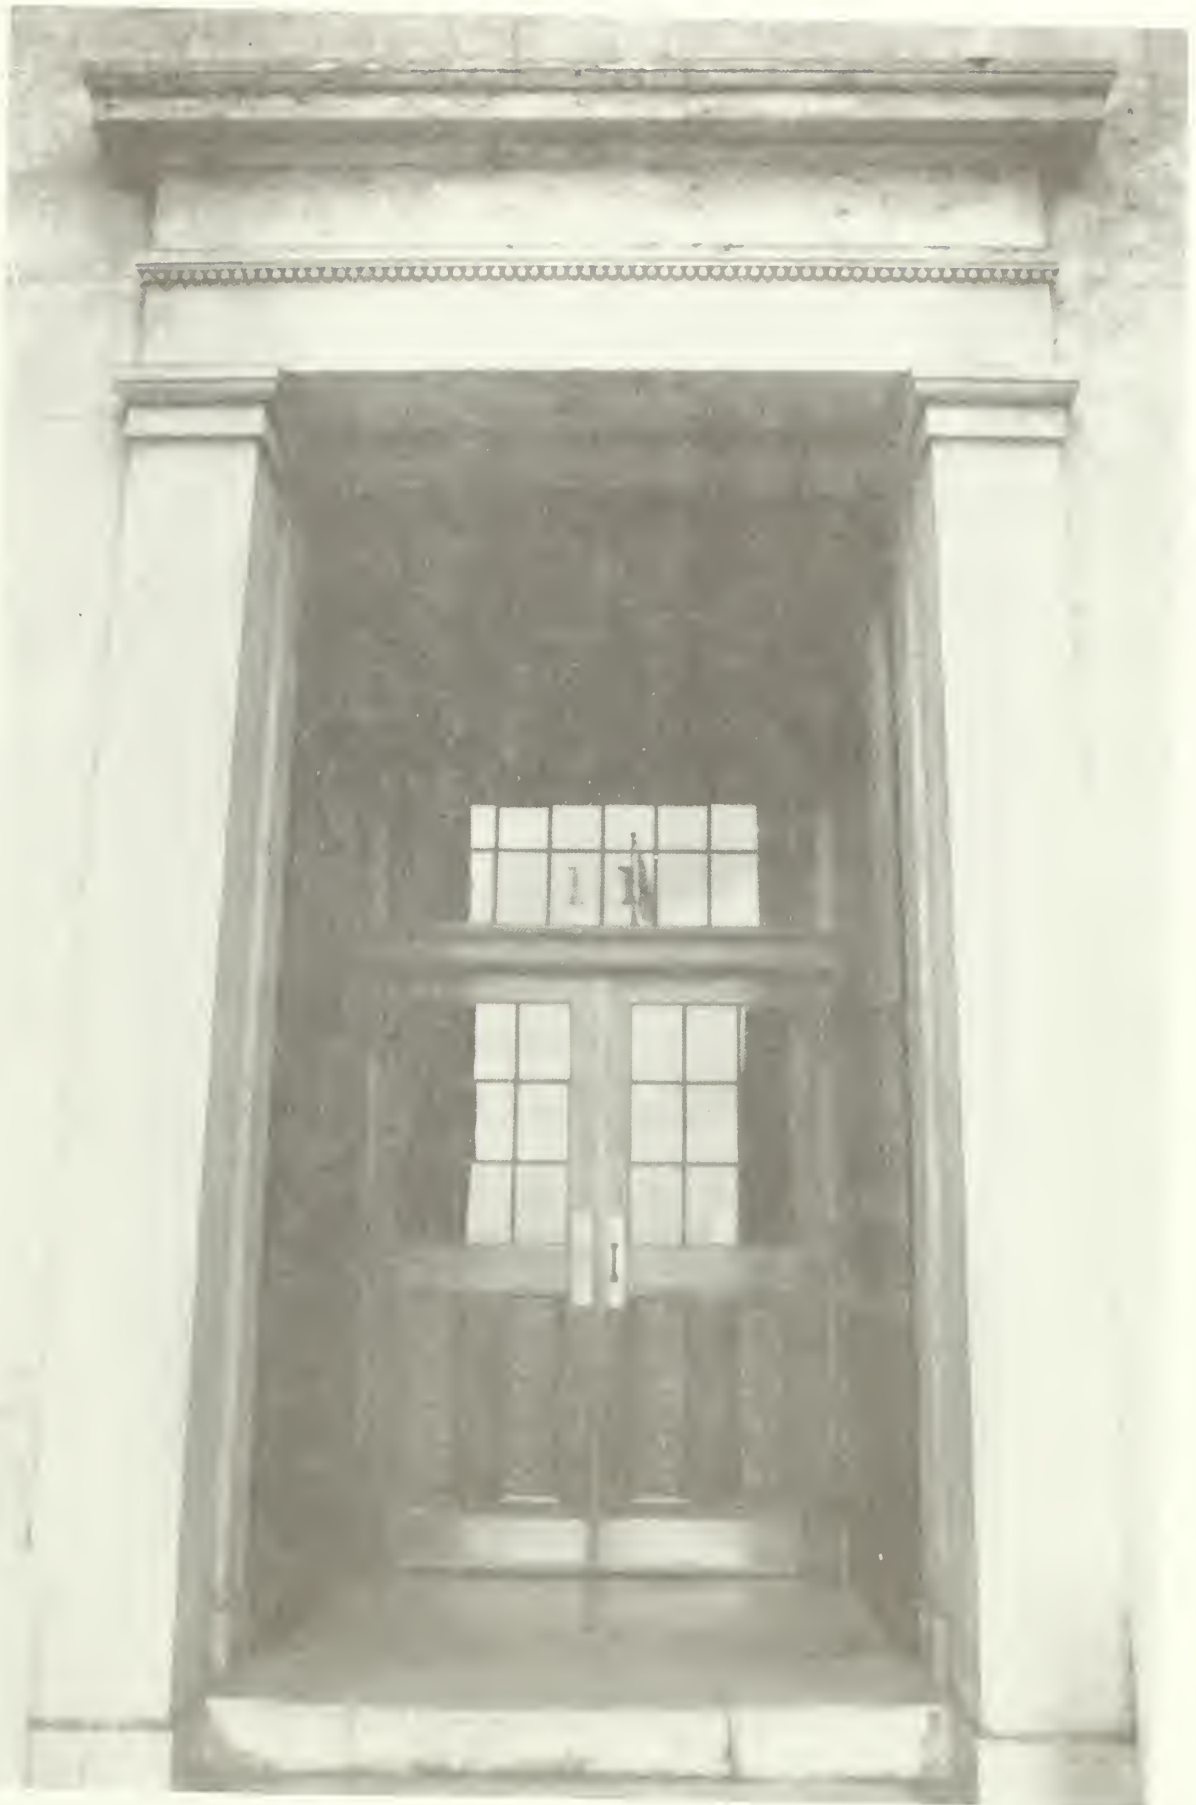
44. Doorway, east portico main entrance. All main entrances are in good condition.

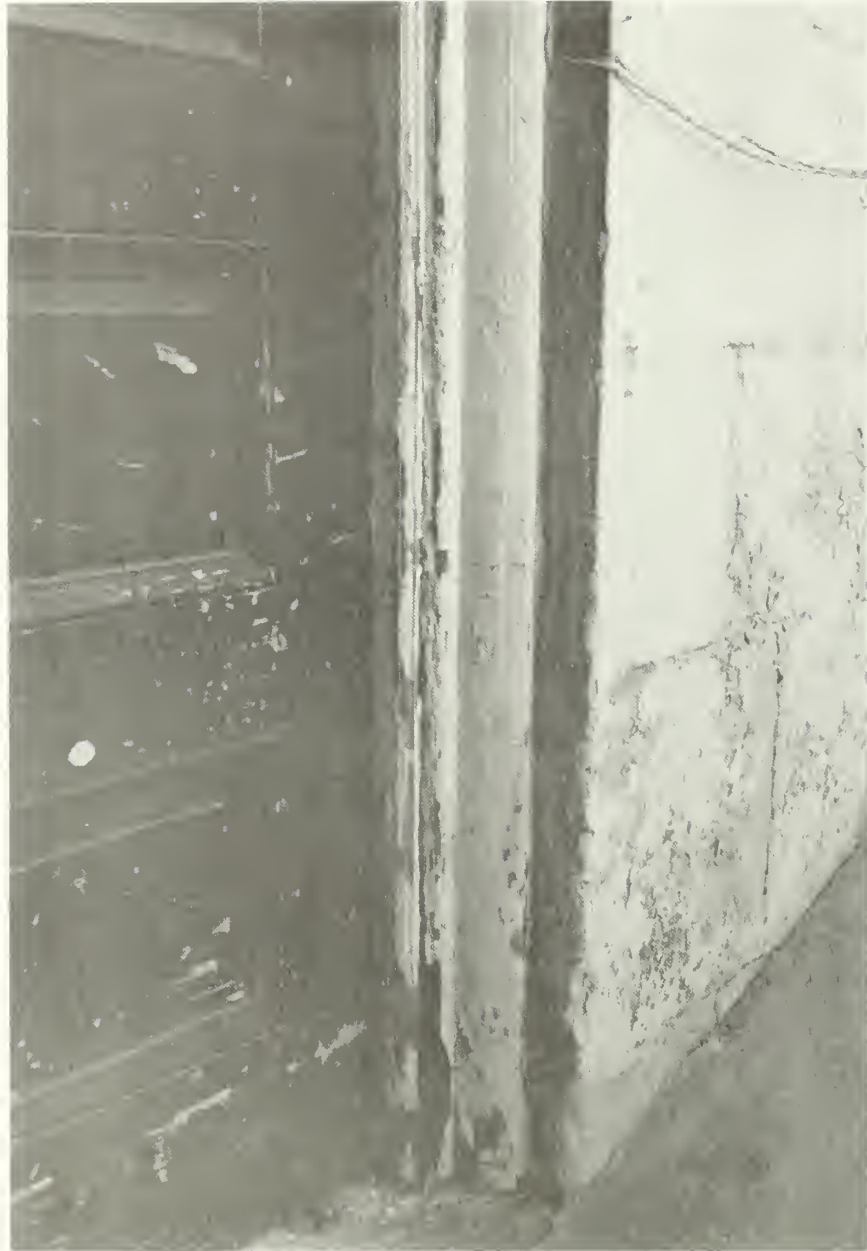
45. Typical deterioration at lower portion of basement doors and jamb.

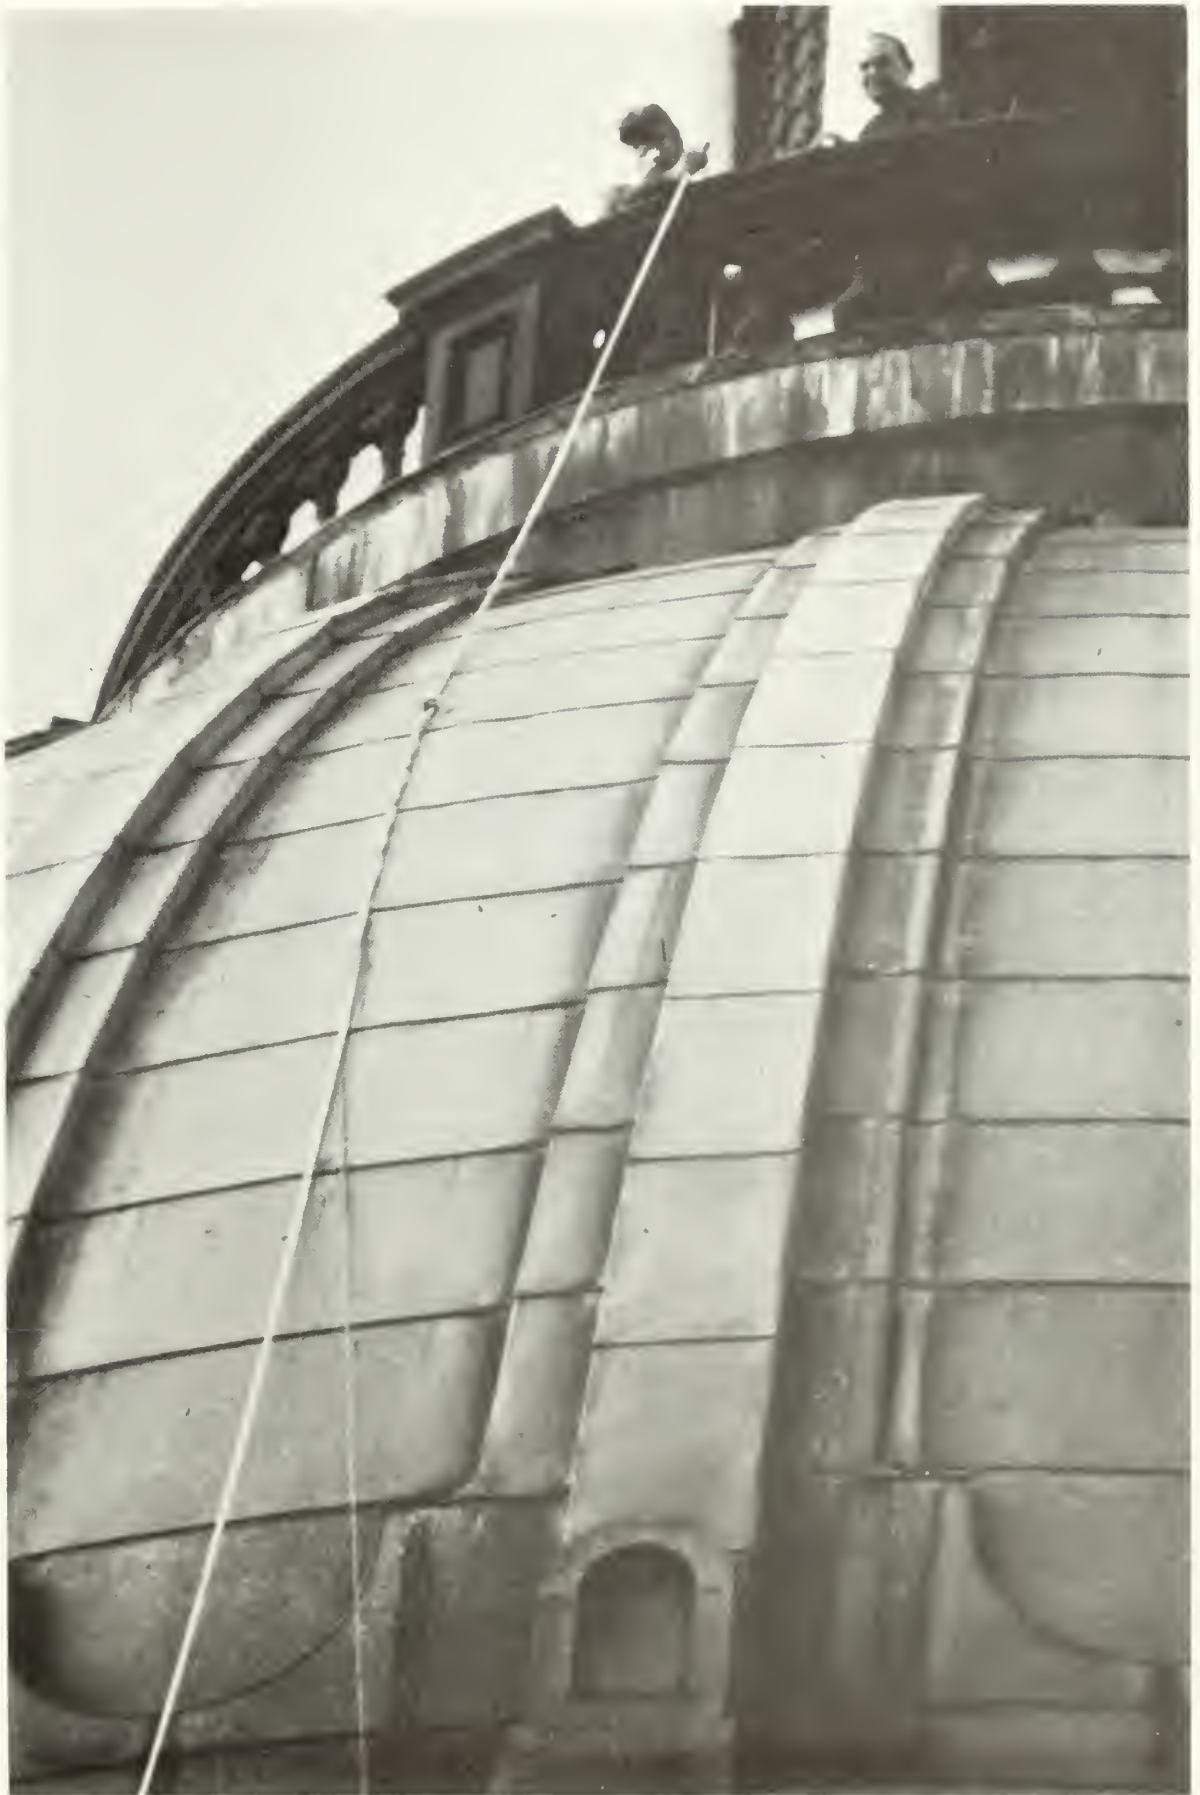
68. Upper dome and lantern. Note staining below balustrade.
